The Token Creek Ecosystem Restoration Project

Jim Krause

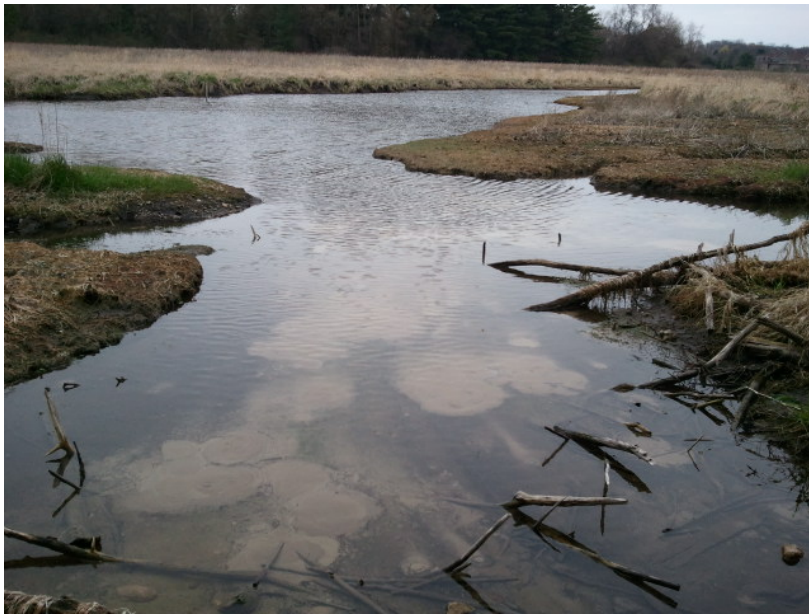
Photo 2.

One of a series of boils and springs immediately south of the Token Creek headwaters, overlooking an extensive wetlands as viewed in spring prior to the new seasonal vegetative growth. (Photo by Jim Krause)

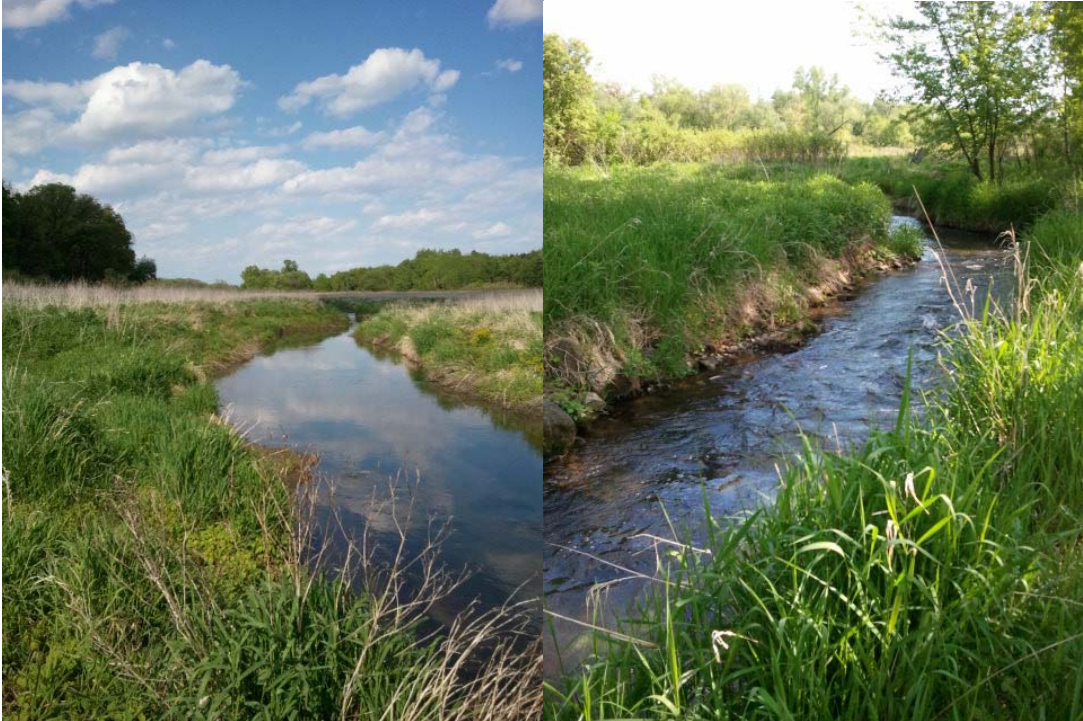
Photo 3.

Token Creek in 2015 above the original grist mill location. The picture on the left shows a portion of the restoration project where the creek banks were recently reconstructed and the picture on the right shows the native vegetative growth along the stream in a more mature area. The embankment shrubs and trees help to maintain the cold water habitat by allowing shade along this local meander. These areas are above and below the pedestrian bridge at the DNR Ponds entrance to the Token Creek Conservancy. (Photos by Jim Krause)

cubic yard capacity silt trap was created within the Dane County Token Park in order to capture sediment that was mobilized from dam removal. Polymer stations were also established above the silt trap to act as stimuli for particle deposition within the trap. Pond sediments above the previous dam were about ten feet thick, consisting largely of silt and peat-like organic vegetative matter. In 2006 and 2007, the channel was dug to a depth of about five feet for a distance of a several hundred feet, with channel deepening that followed the newly formed meanders. The stream bed was dug down to the level of the glacial sand and gravel deposits now forming the bottom of the creek. This provides a home for insects and other aquatic life, re-establishing a food chain that was lost under the 5 feet of sediment. Also, new stream banks were sloped at a four to one ratio, seeded, and mulched (see photos of creek banks).
